Modified Signage and Pavement Markings  
Requiring Vehicles to Stop Behind Light Rail  
Vehicles Stopped to Board or Alight  
Passengers

**Final Evaluation Report**

CTCDC Experiment 16-07

San Francisco Municipal Transportation Agency

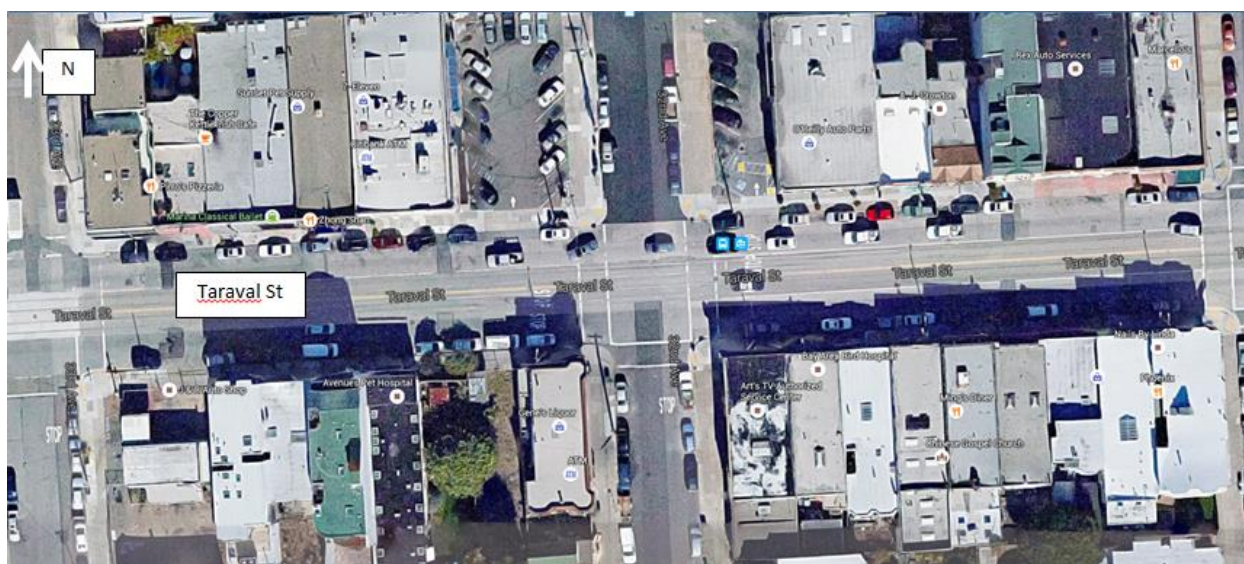
Figure 1. Aerial of Taraval Street (via Google Maps)

The L Taraval line carries 29,000 passengers per day and operates along a 2.7-mile surface segment in each direction, in addition to a subway segment. The majority of the surface segment is on Taraval Street, which is 60 feet wide, with 2 travel lanes in each direction and parking on each side of the street. The LRVs travel on the inside lane of each direction and board/alight passengers from/to the curb lane. There are no established protected passenger facilities on Taraval Street such as boarding islands or transit sidewalk bulb-outs at 23 of the 27 surface transit stops. San Francisco is the only city in California that has passengers board and alight an LRV from an active traffic lane, which is a holdover from Taraval Street's history as a streetcar line with much lower traffic volumes. As a result, this problem is unique to this jurisdiction.

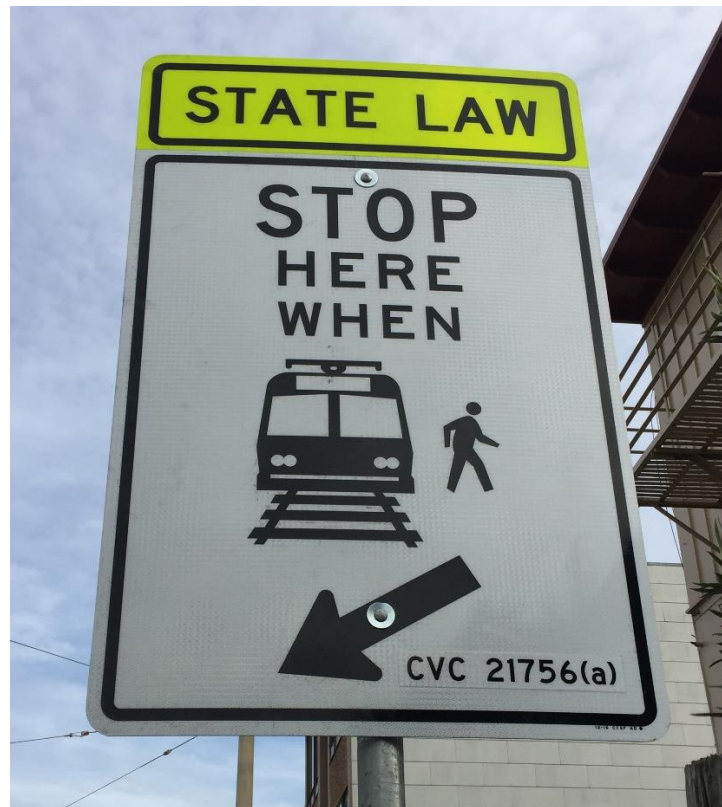
Figure 3. Experimental Sign

- (1) **Modified Signage** – A new sign was created from the combining existing signs (R15-5 and R10-6) and adding “STATE LAW” and the CVC section 21756(a). The dimensions of the sign are 30” wide and 48” tall. Refer to Figure 3 for a photo of the sign.

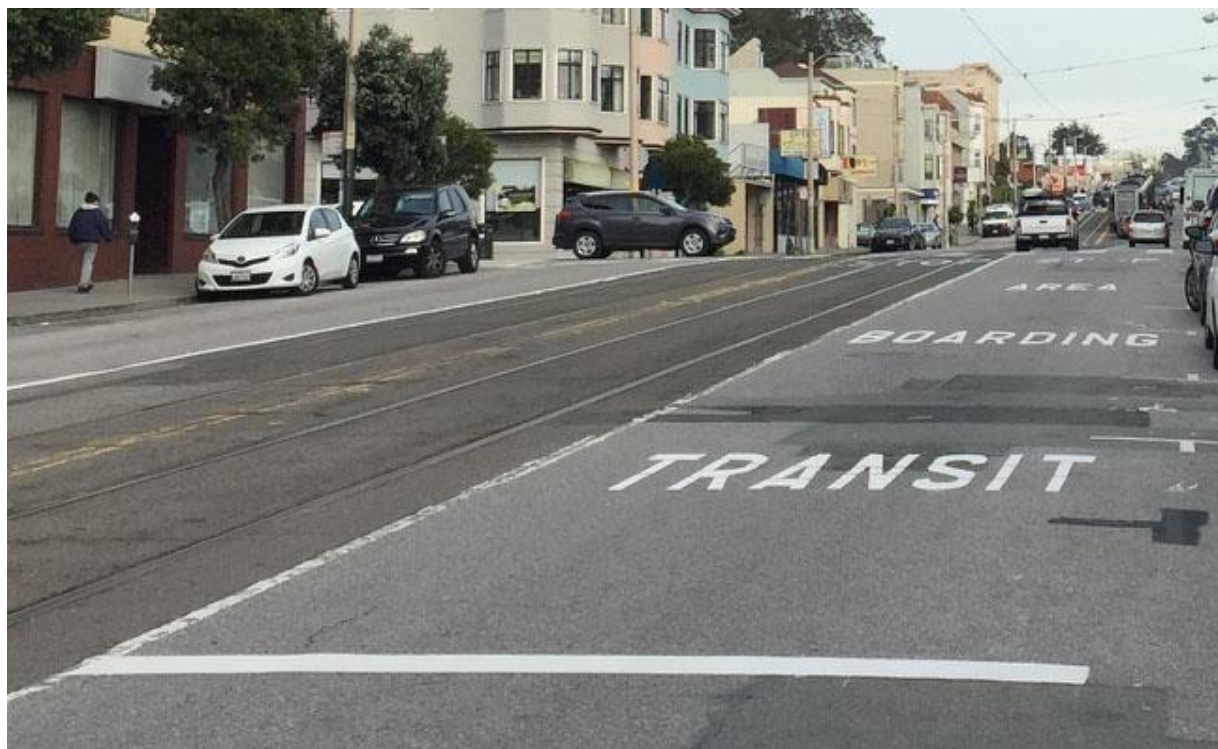
Figure 4. New Pavement Markings

- (2) **Pavement Markings** – a 12” solid white limit line was painted approximately 150 feet upstream of the transit stop to match the length of the typical LRV configuration (2-car trains). The words “TRANSIT BOARDING AREA” were painted with each letter sized at 6’ tall by 1’ wide (the maximum height to fit within the width of the #2 travel lane). Refer to Figure 4.

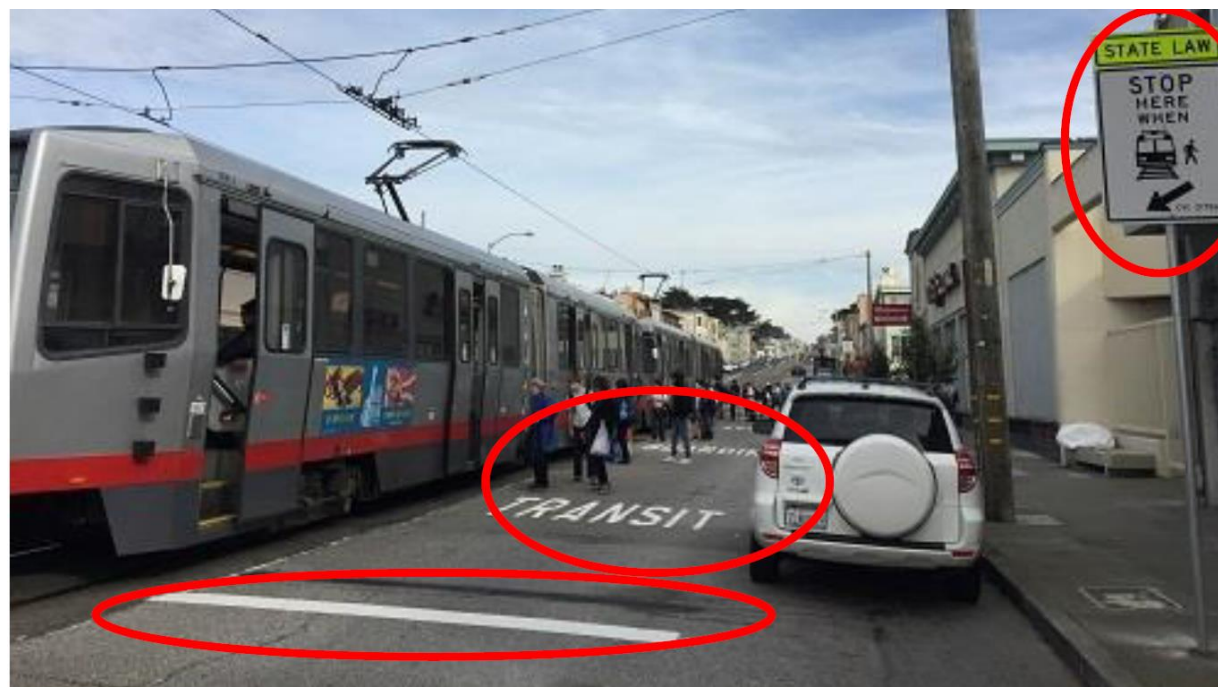
Figure 5. Experimental Treatments

Figure 5 shows all the experimental treatments (circled in red) adjacent to a stopped LRV.

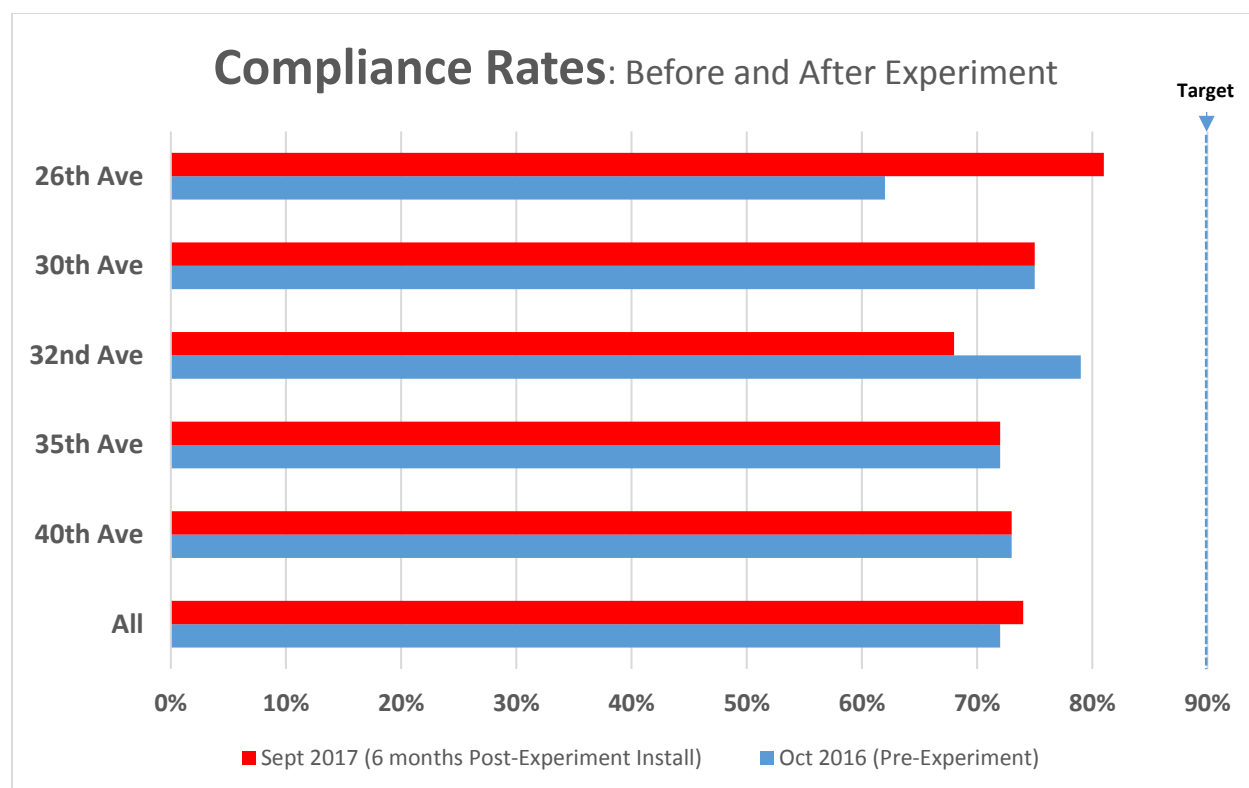
Figure 7. Compliance rate of vehicles stopped when train doors are open

Figure 7 on the next page shows a chart summarizing the compliance rates before the experimental treatments were installed (October 2016) and six months after the experimental treatments were installed (September 2017).

In fall 2016, before the experimental treatments were installed, 72% of cars stopped behind the train when train doors were open. The experimental treatments were installed in April 2017. In May 2017, preliminary data was collected to provide a reference check on how the evaluation was functioning. The compliance rate improved from 72% to 75% one month after implementation.

The target compliance rate was set at 90% through community input and approval of the SFMTA Board of Directors (the governing body that oversees SFMTA). The final results of the evaluation in September 2017 showed a final compliance rate of 74%, which was 16 percentage points below the target compliance rate.
